Manhole Inspection Summary

Manhole # S01CC2001MH

Insp Date: **10/25/06 11:10 AM**

Location Address: **6321 PEARCE AVE**

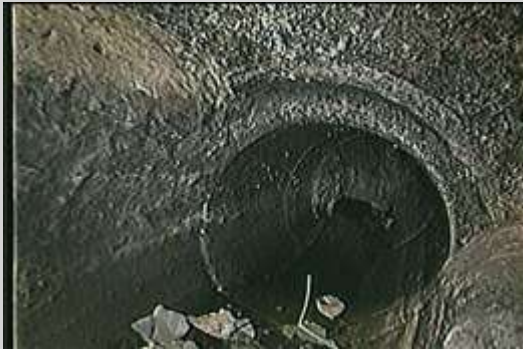
8 in. Circular Gravity Sewer Pipe Out @ 12 O'Clock

Pipe Material: **Clay** ☐ Pipe Lined

Invert Depth: **5.02** (ft.) Flow Characteristics: **Slow**

Deposits: ☒ None ☐ **Mud** ☐ Sludge ☐ **Debris** ☐ Grease

Infiltration: **None** Pipe Seal Cond: **Unknown**

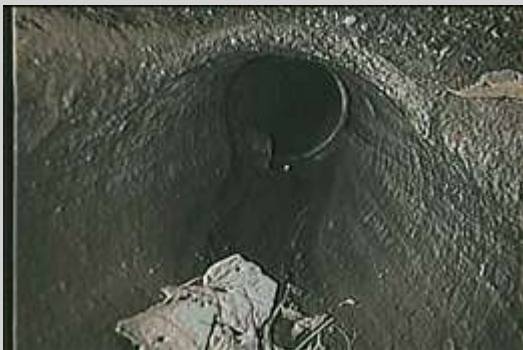
8 in. Circular Gravity Sewer

Pipe Material: **Clay** ☐ Pipe Lined

Infiltration: **None** Pipe Seal Cond: **Unknown**
